FINAL REPORT FUE 24266

Investigation of possible damage to solar modules by cleaning machine from Cleantecs GmbH

Fraunhofer Institute for Solar Energy Systems
in Freiburg

Cleantecs GmbH
Grundweg 10
89250 Senden

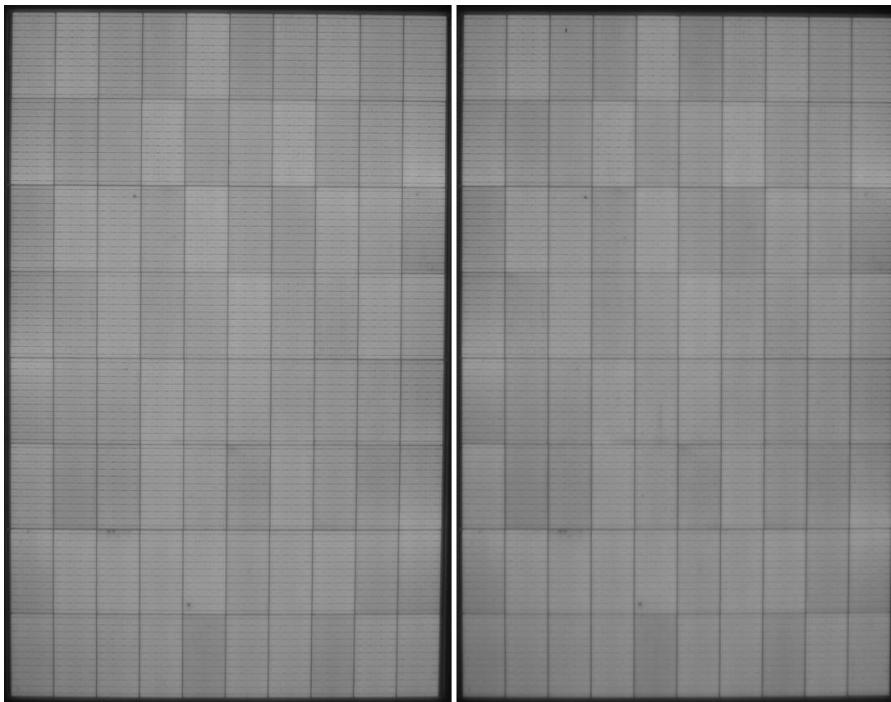
Figure 05 Electroluminescence images M01 Heckert, initial (left) and after cleaning (right)

No cell breakage can be detected before or after cleaning.

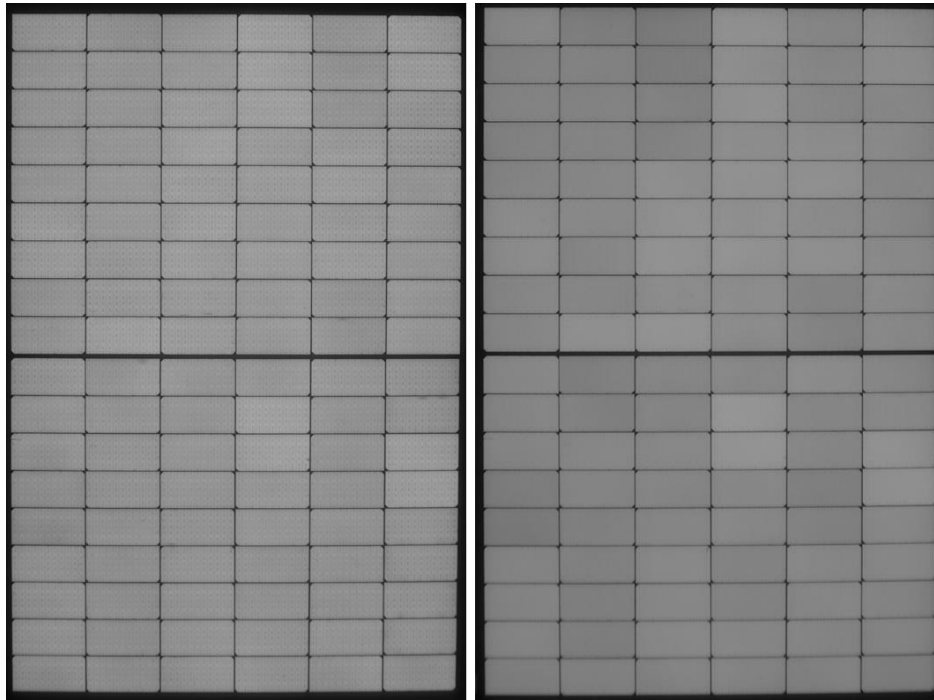
Figure 06 Electroluminescence images M03 JA-Solar, initial (left) and after cleaning (right)

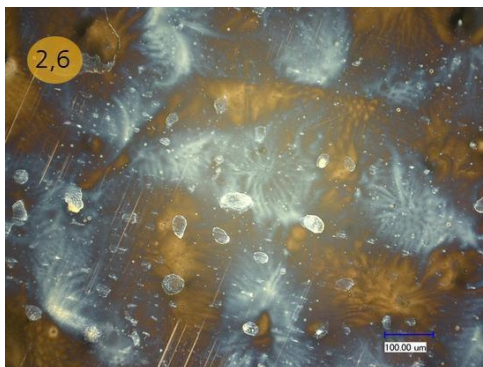
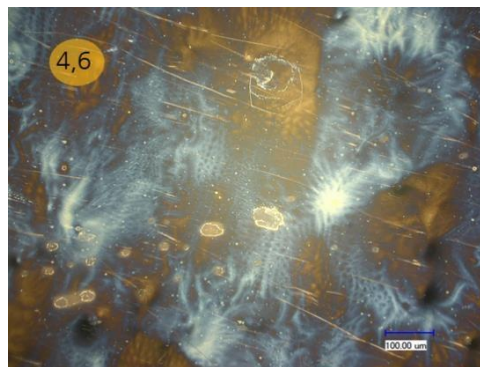
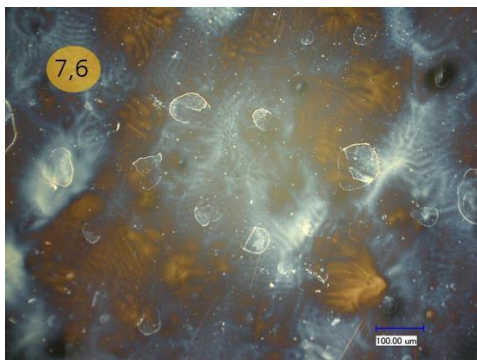
Figure 09 Light microscope images, X100, at M01 Heckert, in the 3 analysed areas

Isolated scratches were found in the reference region (i.e. the non-cleaned area). These may have been caused by transport or handling. There are

Scattered scratches are still visible in the area cleaned with Soltacs W. No damage is recognisable in the area treated with the lichen remover.

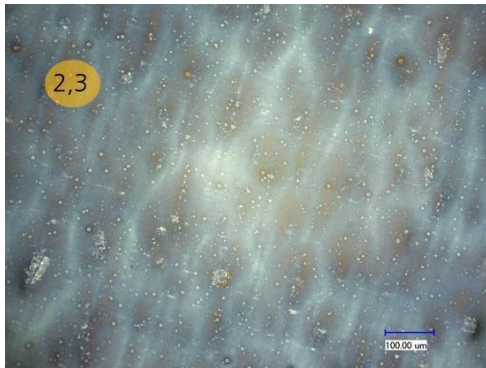
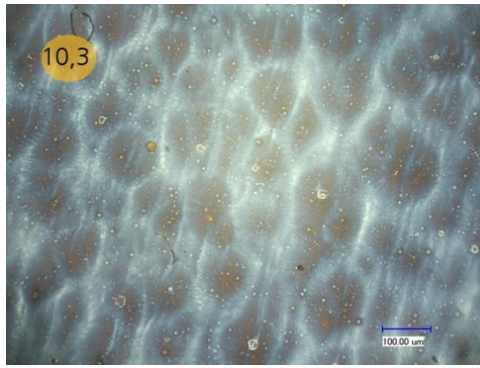
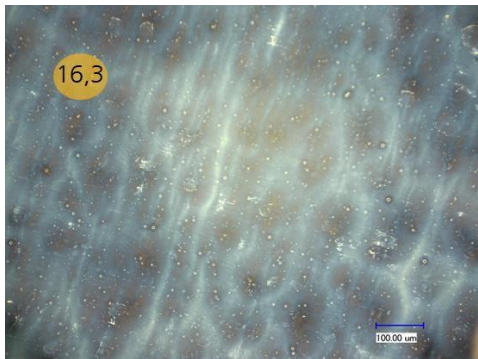
Figure 11 Light microscope images, X100, on M03 JA-Solar, in the 3 areas analysed

No abnormalities are visible before and after cleaning.

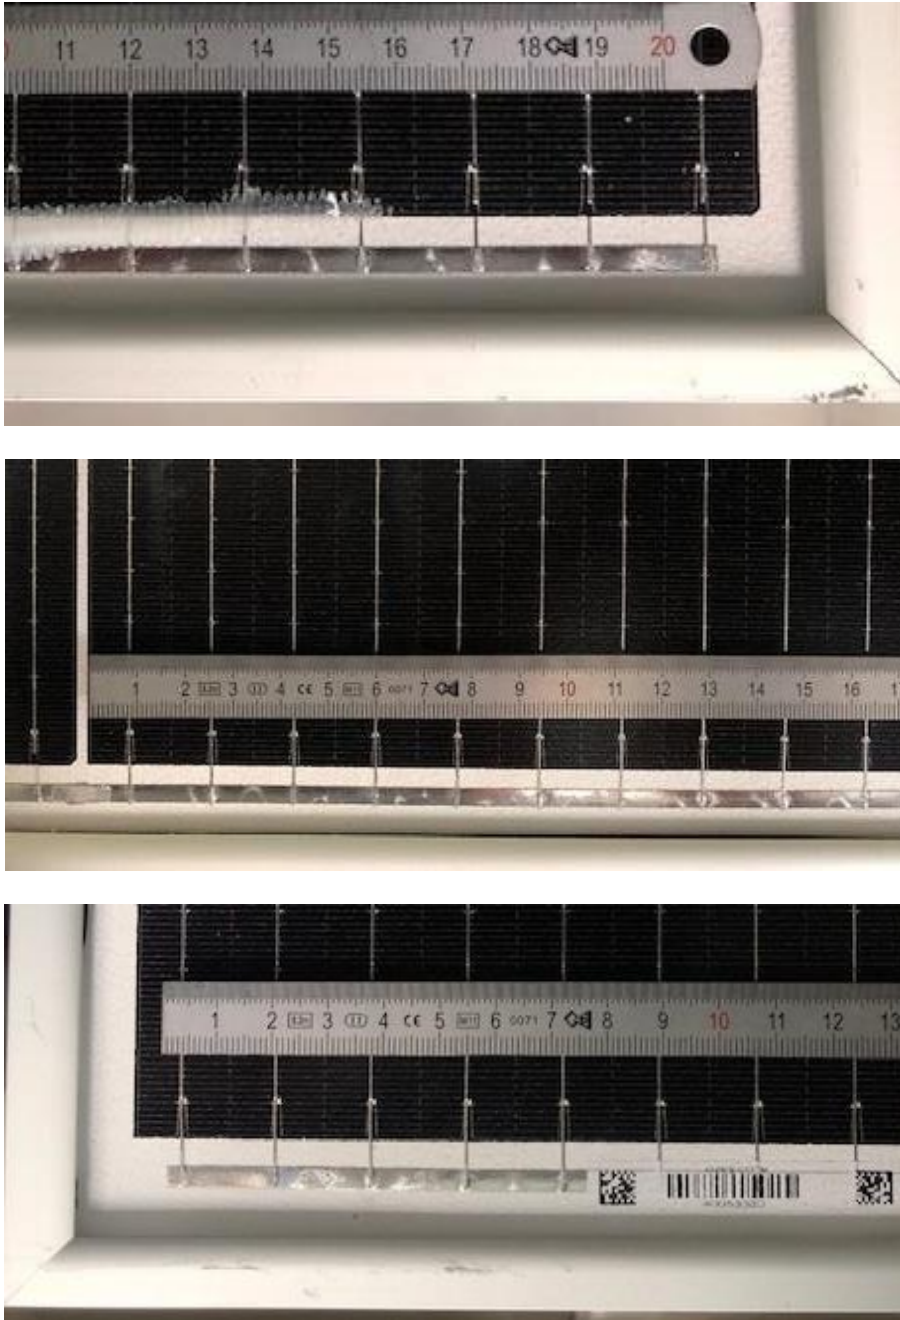
Figure 12 Photographs at M01 Heckert, initial (top), after brush cleaning (centre) and after lichen cleaning (bottom)

There is no visible damage to the lower edge of the module as a result of cleaning.

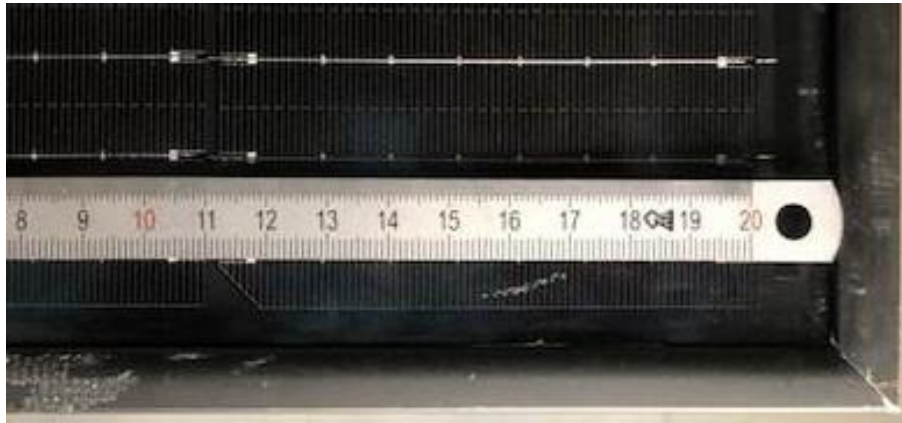
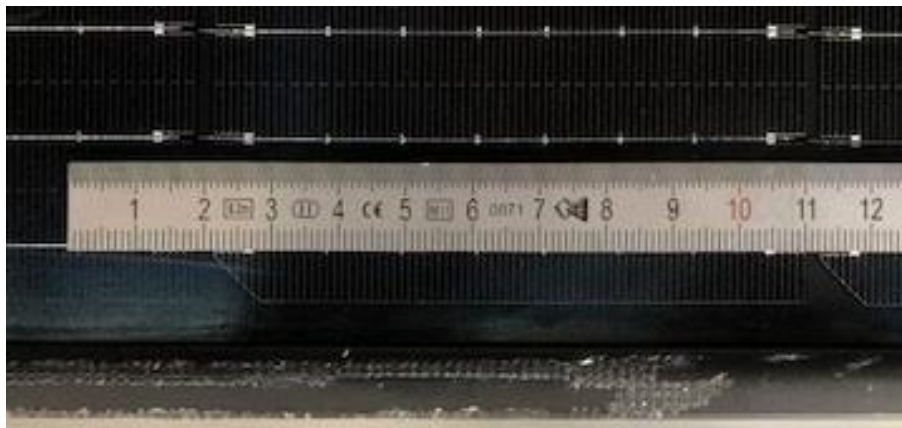
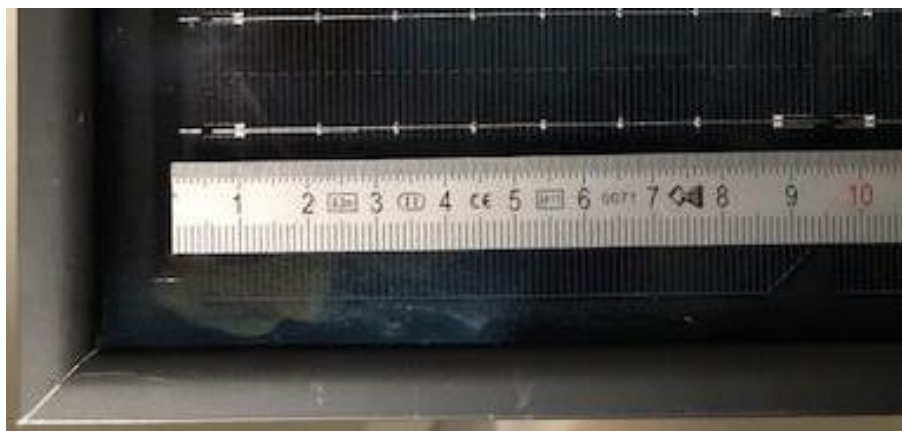
Figure 13 Photographs of the M03 JA-Solar, initial (top), after brush cleaning (centre) and after lichen cleaning (bottom)

There is no visible damage to the lower edge of the module as a result of cleaning.
