FINAL REPORT FUE 24266

Investigation of possible damage to solar modules by cleaning machine from Cleantecs GmbH

Fraunhofer Institute for Solar Energy Systems
in Freiburg

Cleantecs GmbH
Grundweg 10
89250 Senden

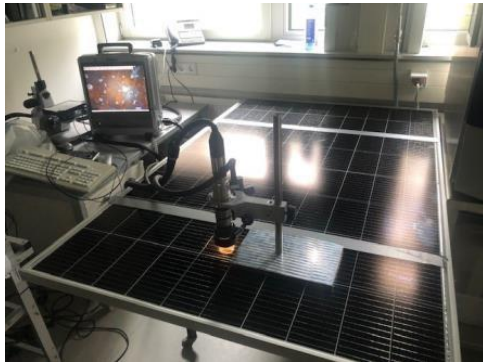
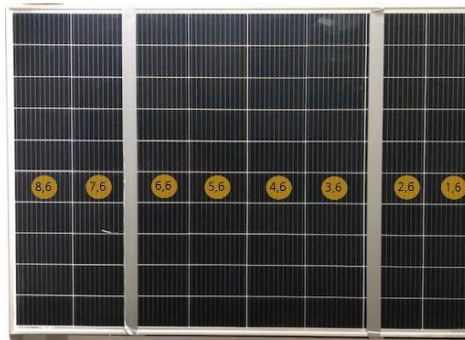
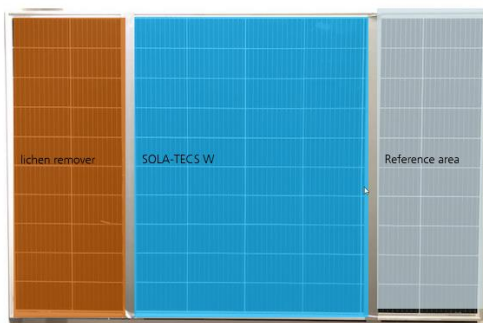
Figure08 Top left: Module M01(Fa.Heckert) during imaging with the light microscope attachment
Top right: Module M01 with the analysed measuring positions
Bottom left: Allocation of the surfaces to the cleaning systems used or Reference area

Isolated scratches were found in the reference region (i.e. the non-cleaned area). These may have been caused by transport or handling. There are

Scattered scratches are still visible in the area cleaned with Soltacs W. No damage is recognisable in the area treated with the lichen remover.

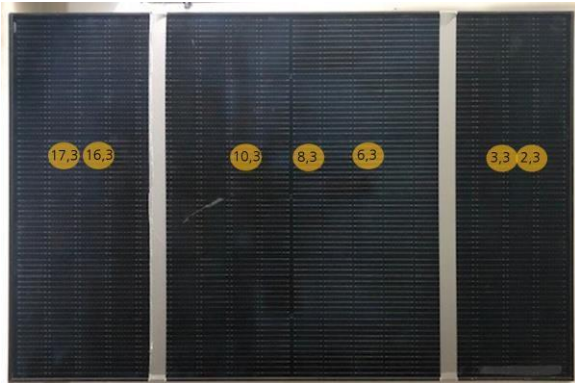
Figure 10 Module M03 (JA Solar) with the analysed measuring positions
